## **Buried Pipe and EPS detection by Ground Penetration Radar**

Nowadays in Seoul, Korea, the ground subsidence caused by sewage leaks has occurred frequently. The purpose of this study is to collect the basic data of subsidence detection by ground penetration radar (GPR) equipment. GPR detection variables are depth and distance of cast iron pipe and expanded polystyrene (EPS) which were buried in the test bed. Based on detection results, possible EPS detection depths were found to be 0.5m and 1m. The detection of EPS at a depth of 1.5m was not possible. Furthermore, if the EPS was closely located below or at side of the cast iron pipe, its detection was impossible due the high-intensity signal of the cast iron pipe. Furthermore the efficiency of developed program GPRiPP was verified based on the comparison of the GPR detected images, generated by commercial program RADAN 7 and GPRiPP.

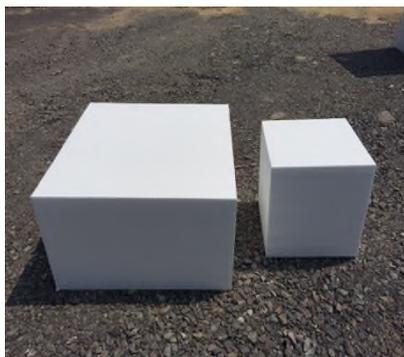
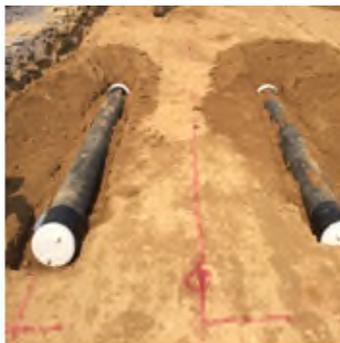
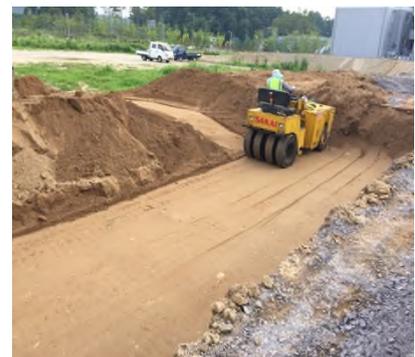
Fig. 3 Test bed construction

(a) EPS

(b) Cast iron pipe

(c) Compaction

of 1m from the surface of the ground. The cavity was formed using expanded polystyrene (EPS) with a cubic length of 500mm in the test bed. In addition, each of the EPS was embedded at depths of 0.5m, 1.0m, 1.5m, and the horizontal length between EPS and the cast iron pipe was 0.75m. After the burying of the cast iron pipe and EPS in test bed, the general soils were used for landfills. Fig.1 shows a test bed in detail. Moreover GPR image processing results elicited by the existing GPR image processing program (RADAN 7) and the developed program (GPRiPP) in this study were compared. The GPR equipment used included the SIR-3000 systems of Geophysical Survey Systems, Inc. and a 400 MHz antenna that was used for cavity detection. Fig.2 shows the GPR detected lines, and Fig. 3 shows the installation pictures of test bed.
