Structural Assessment of Underground Water Reservoirs

ABSTRACT

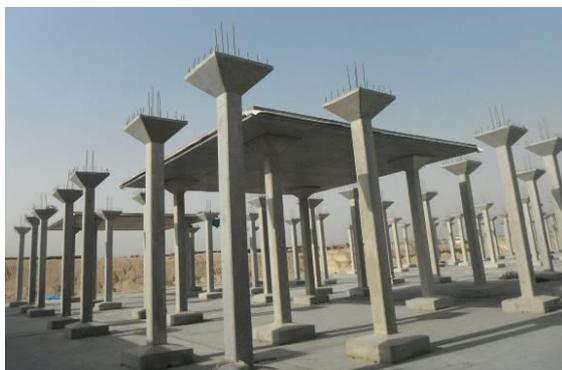
Fig. 2. Typical unit of the roof slab panels supported on four precast columns.

The investigated underground reservoirs typically consist of cast-in-situ bottom slab (raft), precast and/or cast-in-situ columns with enlarged sections at both ends, cast-in-situ external walls and internal partitions, and cast-in-situ roof slab panels that have a typical plan dimension of 10 m x 10 m. Each slab panel is supported on four columns at 6.5 m c/c span and 1.75 m cantilever in each direction (Fig. 2). The slab panels are structurally separated without any reinforcement crossing the joints separating them. Fig. 2a shows a typical unit of the roof slab system and Fig. 3 shows the roof system for a complete reservoir with an overall dimension of 200m x 200m x 6m with a typical capacity of 45 MIG (Million Imperial Gallon).

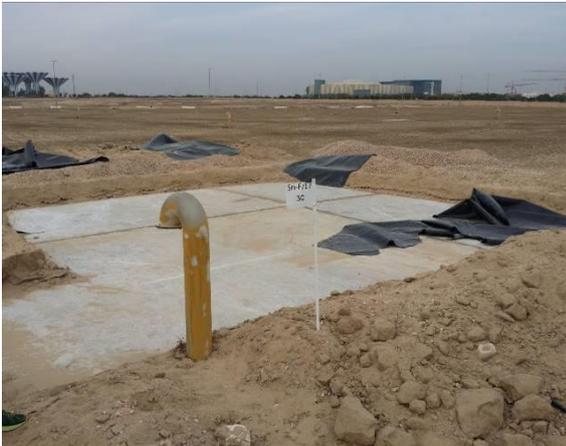
Fig. 5. Typical exposed area of roof slab panels.

The visual inspection of the reinforced concrete (RC) roof slab panels was conducted according to ACI 201.1R (ACI 201.1R, 2008) and it was a challenging task as the top surface of 35 reservoirs were completely covered with a 30 cm thick drainage system (Fig. 4) and because some of the reservoirs are painted with bitumen. Most of the reservoirs had a surface area of 40,000 m². It was impossible and very costly to expose the top surfaces of the RC slab panels and the team was not permitted to use any remote controlled small boats inside the tanks. Therefore, we decided, in agreement with the owner, to expose the top surface of the reinforced concrete slab panels of the reservoirs at most thought critical locations, especially near the water inlets and outlets. In average, the top surfaces of each tank was exposed at 6 locations with a total number of 230 locations in all the tanks. The exposure area at each location was approximately 5x5 m (Fig. 5).
