Vibration-based comparison of accelerometer and microtremor sensors with numerical verification by assessing a PC-bridge

Keywords: Prestressed Concrete bridge; Accelerometer transducer; Microtremor sensor; Natural frequency; Midas civil

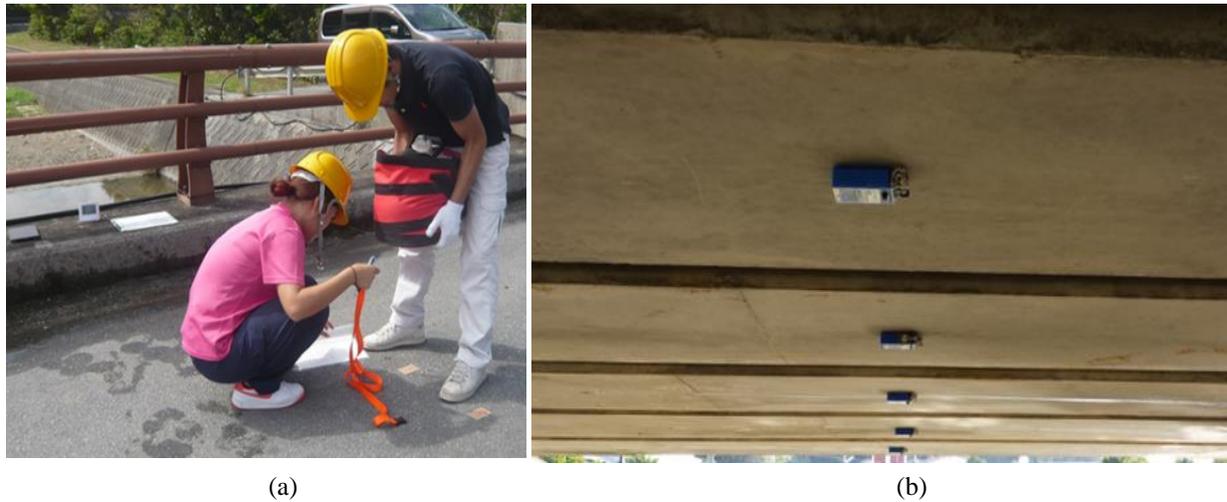
Fig. 5 (a) dropping load illustration (b) positions of accelerometers on the bridge's girders

In this test, an impact load is induced to generate vibration waves by dropping 30kg sandbag from 70 cm height on the points where the portable type of accelerometers are attached to the girders for acquiring the vibration response of the bridge. The reason of using specific type load is to reduce the reflection influence of the weight and to uniformly transmit the shock wave due to free fall of the mass. During free vibration, the response of the bridge is measured through triaxial acceleration transducers (hereinafter referred to as a sensor) with nominal sensitivity range ($\pm 2000\text{gal}$), the trigger level and sampling interval of the sensors is set for data recording to be 20 gals in 2 milli-seconds, accordingly. The sensors are set on the girders, two horizontal components are oriented along the longitudinal and transverse directions, and vertical component is upward positive. For the bridges vertical vibrations are generally dominant rather than horizontal ones that correspond to the fundamental natural frequency. The sensors (s03, PT01, PT02, PT03, PT04 and PT05) are attached to the center of each girder (G1, G2, G3, G4, G5, and G6) as shown in Fig. 5. The vibration is caused by an impact at three locations (mid-span of the bridge, G2 girder and G5 girder) by dropping the mass to vibrate the bridge in various locations.

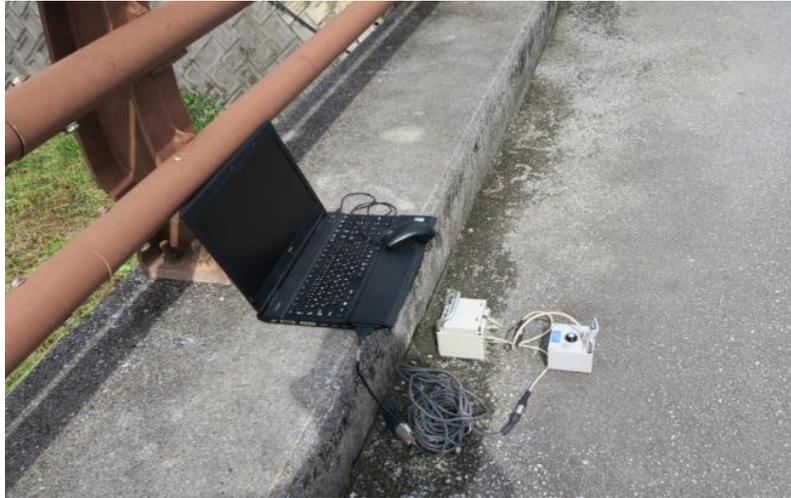
Fig. 7 Data acquisition from microtremor sensors

Microtremor is one of the widely used measurement sensors in the field of structural health monitoring that can detect seismograph with high magnification by measuring ground vibrations with displacement amplitude and velocity amplitude (Rezaei Choobbasti 2017). Surface of the Earth is always in motion at seismic frequencies, even without earthquakes stated by (Okada and Suto 2003). Both, these constant vibrations of the ground surface and the sensor are called microtremor(s). Here, microtremor measurement sensors are permanently installed to the two outside girders (G1 and G6) of the bridge for recording the vibration response for long-term structural health monitoring. Figure 7 shows data collection of microtremor. The sensors are oriented to record the vibration data in a sampling interval of 10 ms in every continuous period of 45 seconds. The advantage of this type of evaluation is that, these sensors are independent. The data can be recorded in the absence of an evaluator and without imposing the

external load that results in avoiding traffic interference. Nevertheless, the professionals recommend measuring the data to be more than one time for confirming the result, because the surrounding noise and other environmental influential factors sometimes disturb the stationarity of the sensors required for data.
